Manhole Inspection Summary

Manhole # S27S__016MH

Location Address: **1620 Bush ST**

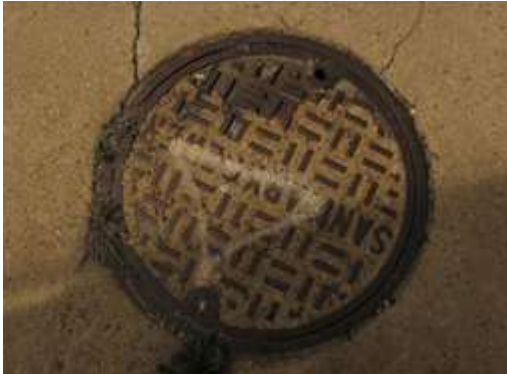
Cover View

Cover Shape: **Circular** Diameter: **25.** (in.) Length: **0** (in.) Dist A/B Grade: **0** (in.)
75

Type: **Sanitary** Condition: **Sound** Cover Material: **Cast Iron**
